DATE: 3-1-70

BRITISH LEYLAND MOTORS INC.
600 Willow Tree Road • Leonia • New Jersey 07605

ALIGNMENT OF AUXILIARY PUMP
TO GOVERNOR ASSEMBLY

AUSTIN AMERICA AUTOMATIC

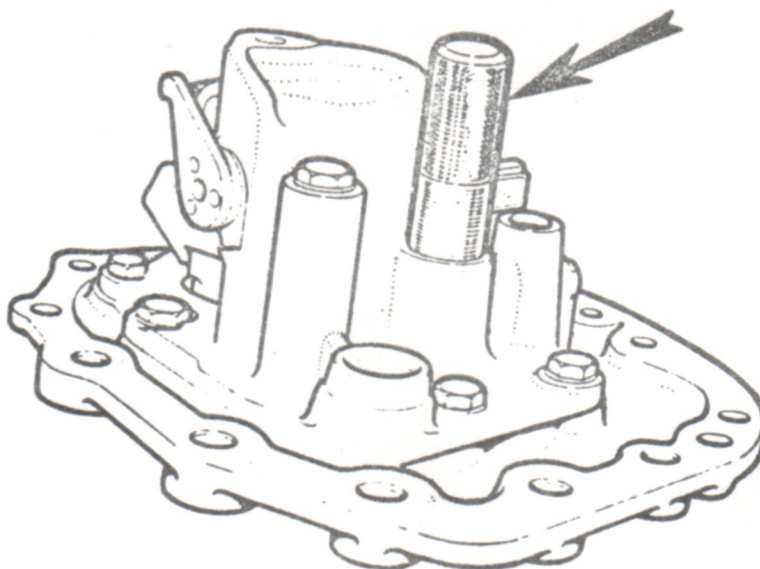
It is vitally important that the auxiliary pump and governor assembly are correctly aligned during re-assembly by using the centralizing tool 18G 1106 as illustrated below:

Failure to observe this procedure may result in seizure and breakage of the auxiliary pump driveshaft, no gear changes in 'D' and loss of speedometer operation.

Refit governor assembly to auxiliary pump leaving securing screws loose: Fit service tool 18G 1106, tighten securing screws to 10/15 lb. ft. and remove service tool.
