Confidential  
TECHNICAL SERVICE BULLETIN

NO. 3 D 5

Delay in Engagement of Drive

MGC Automatic

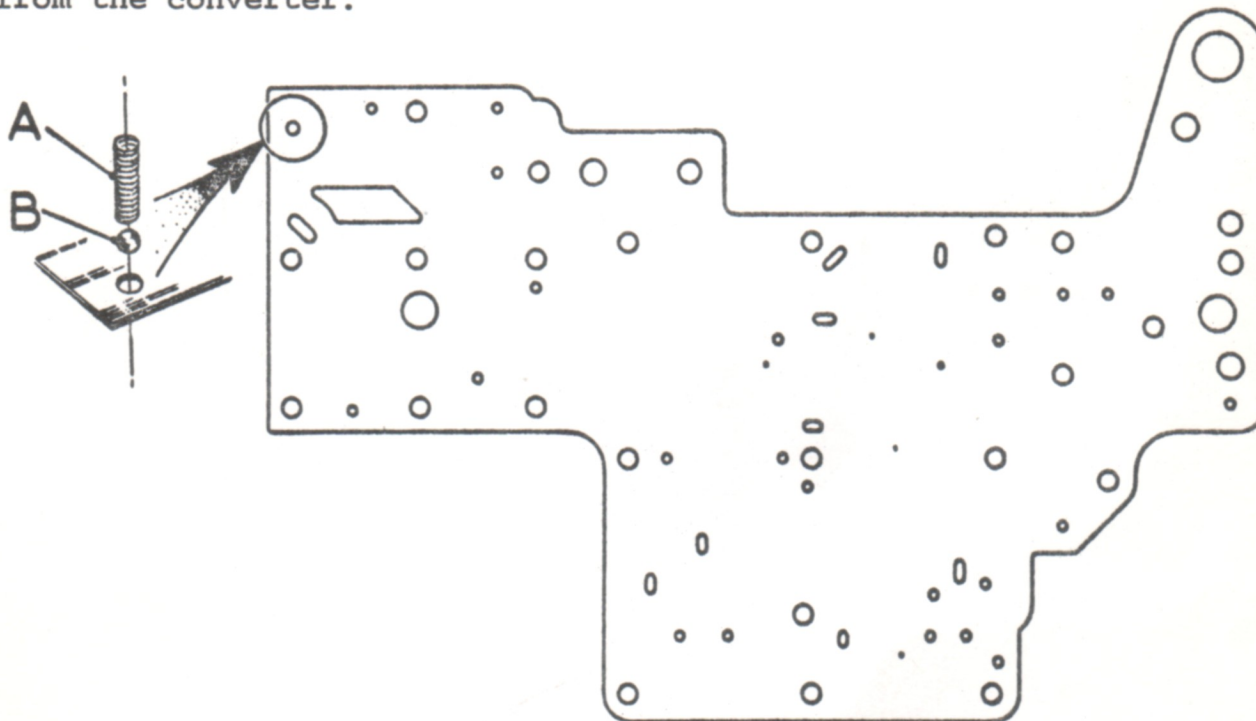
If delay in the engagement of drive is experienced, particularly when starting from cold, it may be caused by wear in hole 'A' in the valve block steel manifold plate, which prevents ball 'B' from seating correctly, allowing oil to drain from the converter.

This condition usually can be ascertained by checking the oil level prior to starting and rechecking after running the engine a few minutes. An appreciable difference in oil levels is usually apparent.

To eliminate this condition, install part number 37H 4647, nylon ball and a new manifold plate, 37H 4139.

Under no circumstances should complete valve block assemblies be replaced for this fault.
