TECHNICAL SERVICE BULLETIN

71 B 12

Fresh Air Heater Controls Outer
Cable Retention.

Austin America

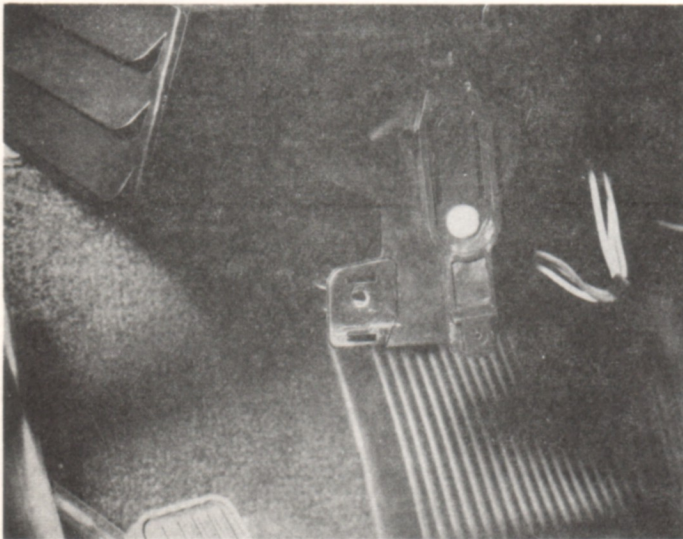
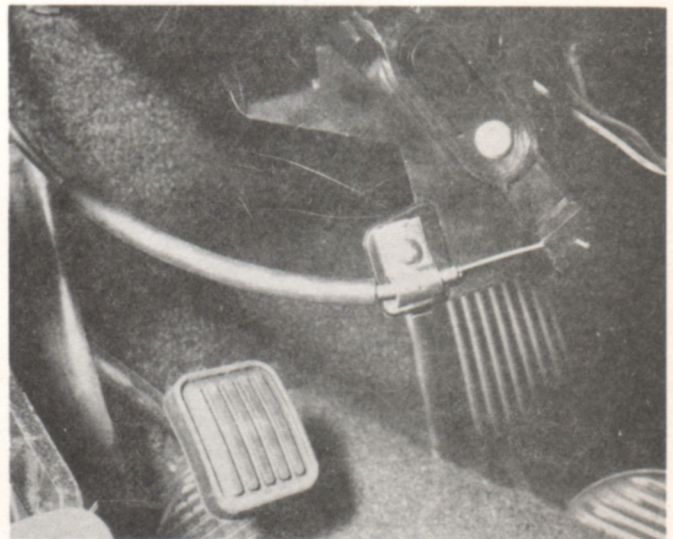
If the outer cable retention clips fail to hold, the following method of repair may be employed:

It may be necessary to slightly increase the bend in the clip if the plastic cracks at the original clip slot.

Remove heater control panel, invert and drill a 3/16" hole as indicated below 5/8" from bottom of flange, center point from side to side.

Install clip, part number 27H1193, and secure to panel with a 8/32 x 1/2" screw and nut.
