TECHNICAL SERVICE BULLETIN

NO. 71 F 12

AUSTIN MG
DIVISION

Premature Brake Pad Wear

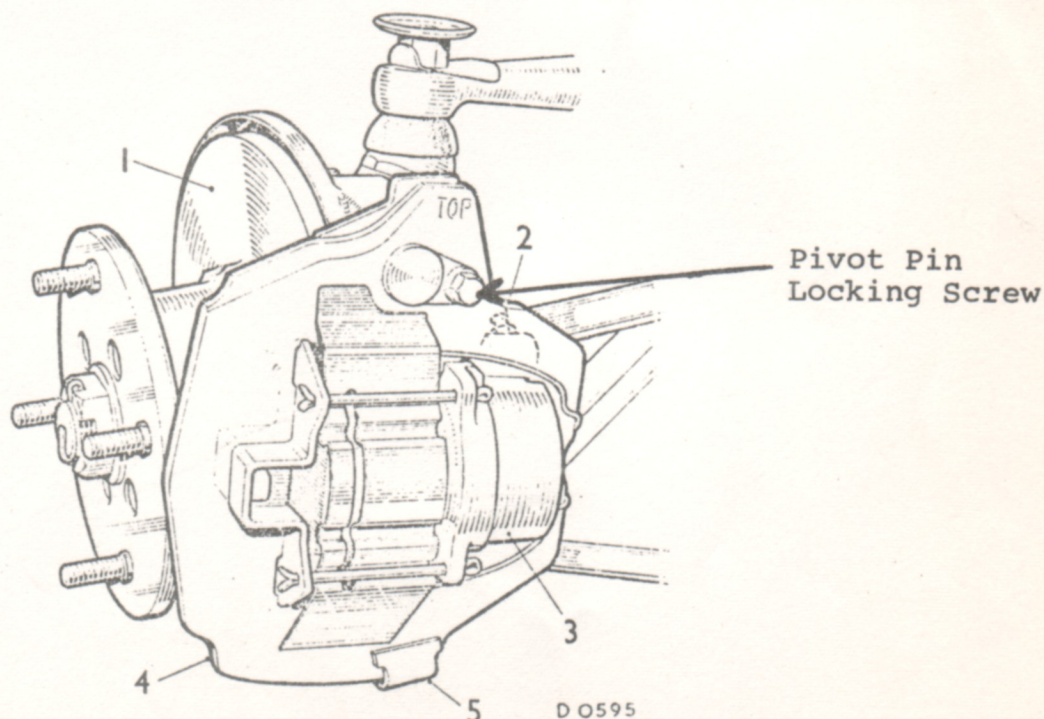
Fig. K.9

Investigation into complaints of premature brake pad wear have been found to be possibly due to incorrectly centred calipers.

The disc brake assembly (swinging calliper type)

It is essential that this adjustment is performed at periodic service intervals or when pads are rotated, by slackening the pivot pin locking screw, pressing the brake pedal several times to centralize the brake pads and retighten the screw to 5-6 ft lbs.
