TECHNICAL SERVICE BULLETIN

NO. 73-A-8

FUEL TANK SLOW FILLING

MARINA

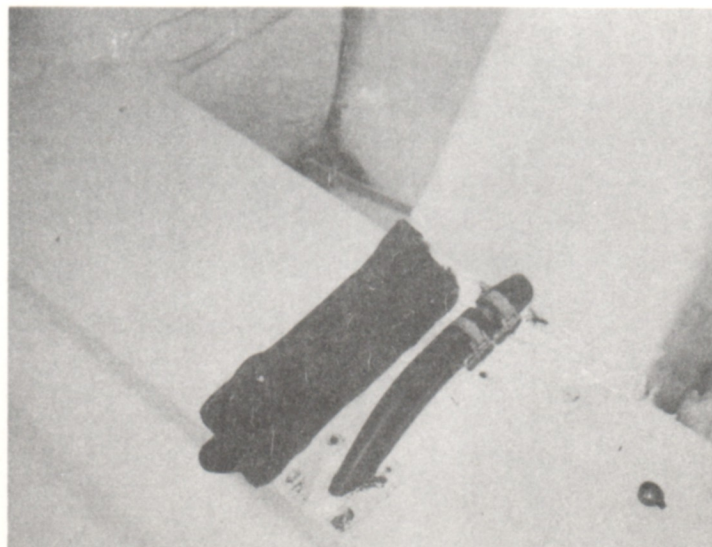
If this condition is encountered, it may be caused by a partially trapped or kinked breather tube.

This can be rectified by removing the trunk mat and removing the four screws securing the protector plate (see photograph) which will expose the breather tube. Check that the tube is free of kinks and that it has not been trapped by the protector plate.

NOTE: It may be necessary to shorten the length of the venting tube to insure a bend-free routing of the tube.
