# TECHNICAL SERVICE BULLETIN

NO. 73/D/6

Difficult Selection and  
Disengagement of Reverse Gear

Austin Marina

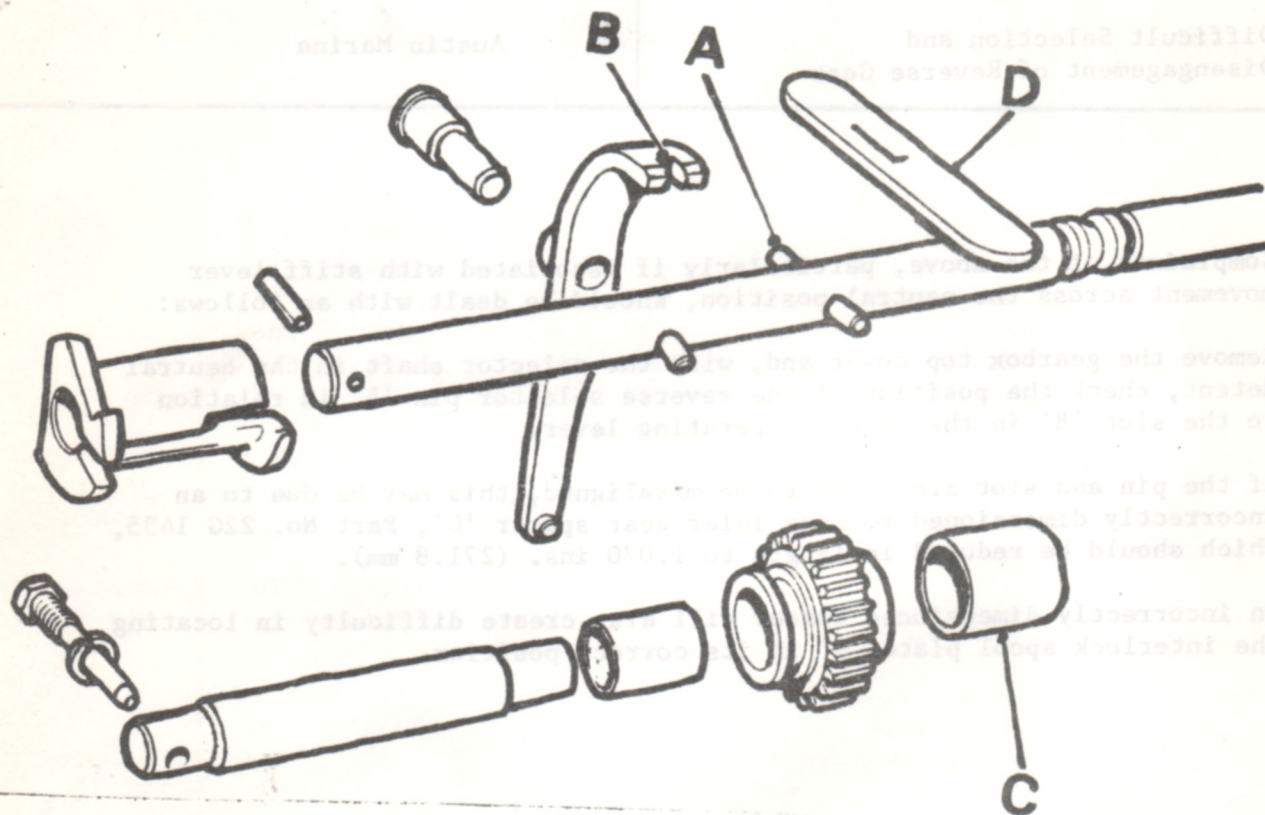
Remove the gearbox top cover and, with the selector shaft in the neutral detent, check the position of the reverse selector pin 'A' in relation to the slot 'B' in the reverse operating lever.

If the pin and slot are found to be misaligned, this may be due to an incorrectly dimensioned reverse idler gear spacer 'C', Part No. 22G 1435, which should be reduced in length to 1.070 ins. (271.8 mm).

An incorrectly dimensioned spacer will also create difficulty in locating the interlock spool plate 'D' in its correct position.
