# Recall Campaign Bulletin

RECALL CAMPAIGN B.177  
Front Suspension Arms  
and Steering Lock Stops

**MARINA**

August 1973

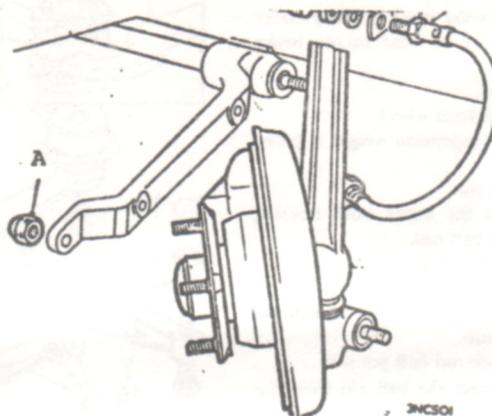
Field reports indicate, on early production Austin Marinas, there is a possibility the steering rack tie rods could bend if the steering wheel was turned onto full lock and the front wheels then forced up against a curb or similar object.

At V.I.N. 124 front wheel lock stops, in the form of a large nut at the outer lower pivot of the front suspension, were installed on production. It is necessary to install these lock stops on all Marinas prior to V.I.N. 124 and check the tie rods for damage.

1. Remove the nuts at the rear outer lower pivot of the front suspension.
2. Replace with large nuts (lock stops 21H-6390) as illustrated (A).

3. Check front wheel alignment. If TOE-OUT condition exists, this is an indication tie rod is bent, most probably at ball end under Gaiter. Remove rack and replace bent tie rod/s and ball housing lock nut/s as necessary. Operation numbers 57-25-07 and 57-65-01.

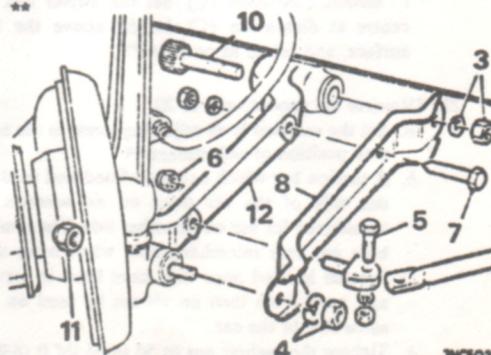
**LOWER SUSPENSION ARM ASSEMBLY**

In addition, at V.I.N. 359, stronger lower suspension arms were installed on production and, although no cases of bent suspension arms have been reported, it has been decided to bring earlier vehicles (prior to V.I.N. 359) up to current production specification by installing two stronger lower arms (see service procedure attached).

1. Jack up the suspension unit under the rear lower arm, fitting suitable safety supports.
2. Remove the hub cap and road wheel.
3. Remove the nut and spring washer from the eyebolt pin.
4. Remove the front nut and spring washer from the swivel lower link pin.
5. Remove the nut, bolt and spring washer retaining the tie-rod to the tie-rod fork.
6. Remove the nut retaining the tie-rod fork and remove the fork.
7. Remove the nut, bolt and spring washer clamping the front and rear lower arms.
8. Remove the front lower suspension arm.
9. Remove the torsion bar. 60.20.42.
10. Remove the eyebolt pin.
- 11.\*\* Remove the rear nut from the swivel lower link pin.\*\*
12. Remove the lower suspension arm.

13. Reverse the procedure in 1 to 12, noting:
  - a. Tighten the tie-rod fork nut to 48 to 55 lbf ft (6.6 to 7.6 kgf m).
  - b. Tighten the tie-rod to fork nut to 22 ibf ft (3.0 kgf m).
