TECHNICAL SERVICE BULLETIN

75-A-6

Austin MG

MIDGET 1500 CC OVERHEATING

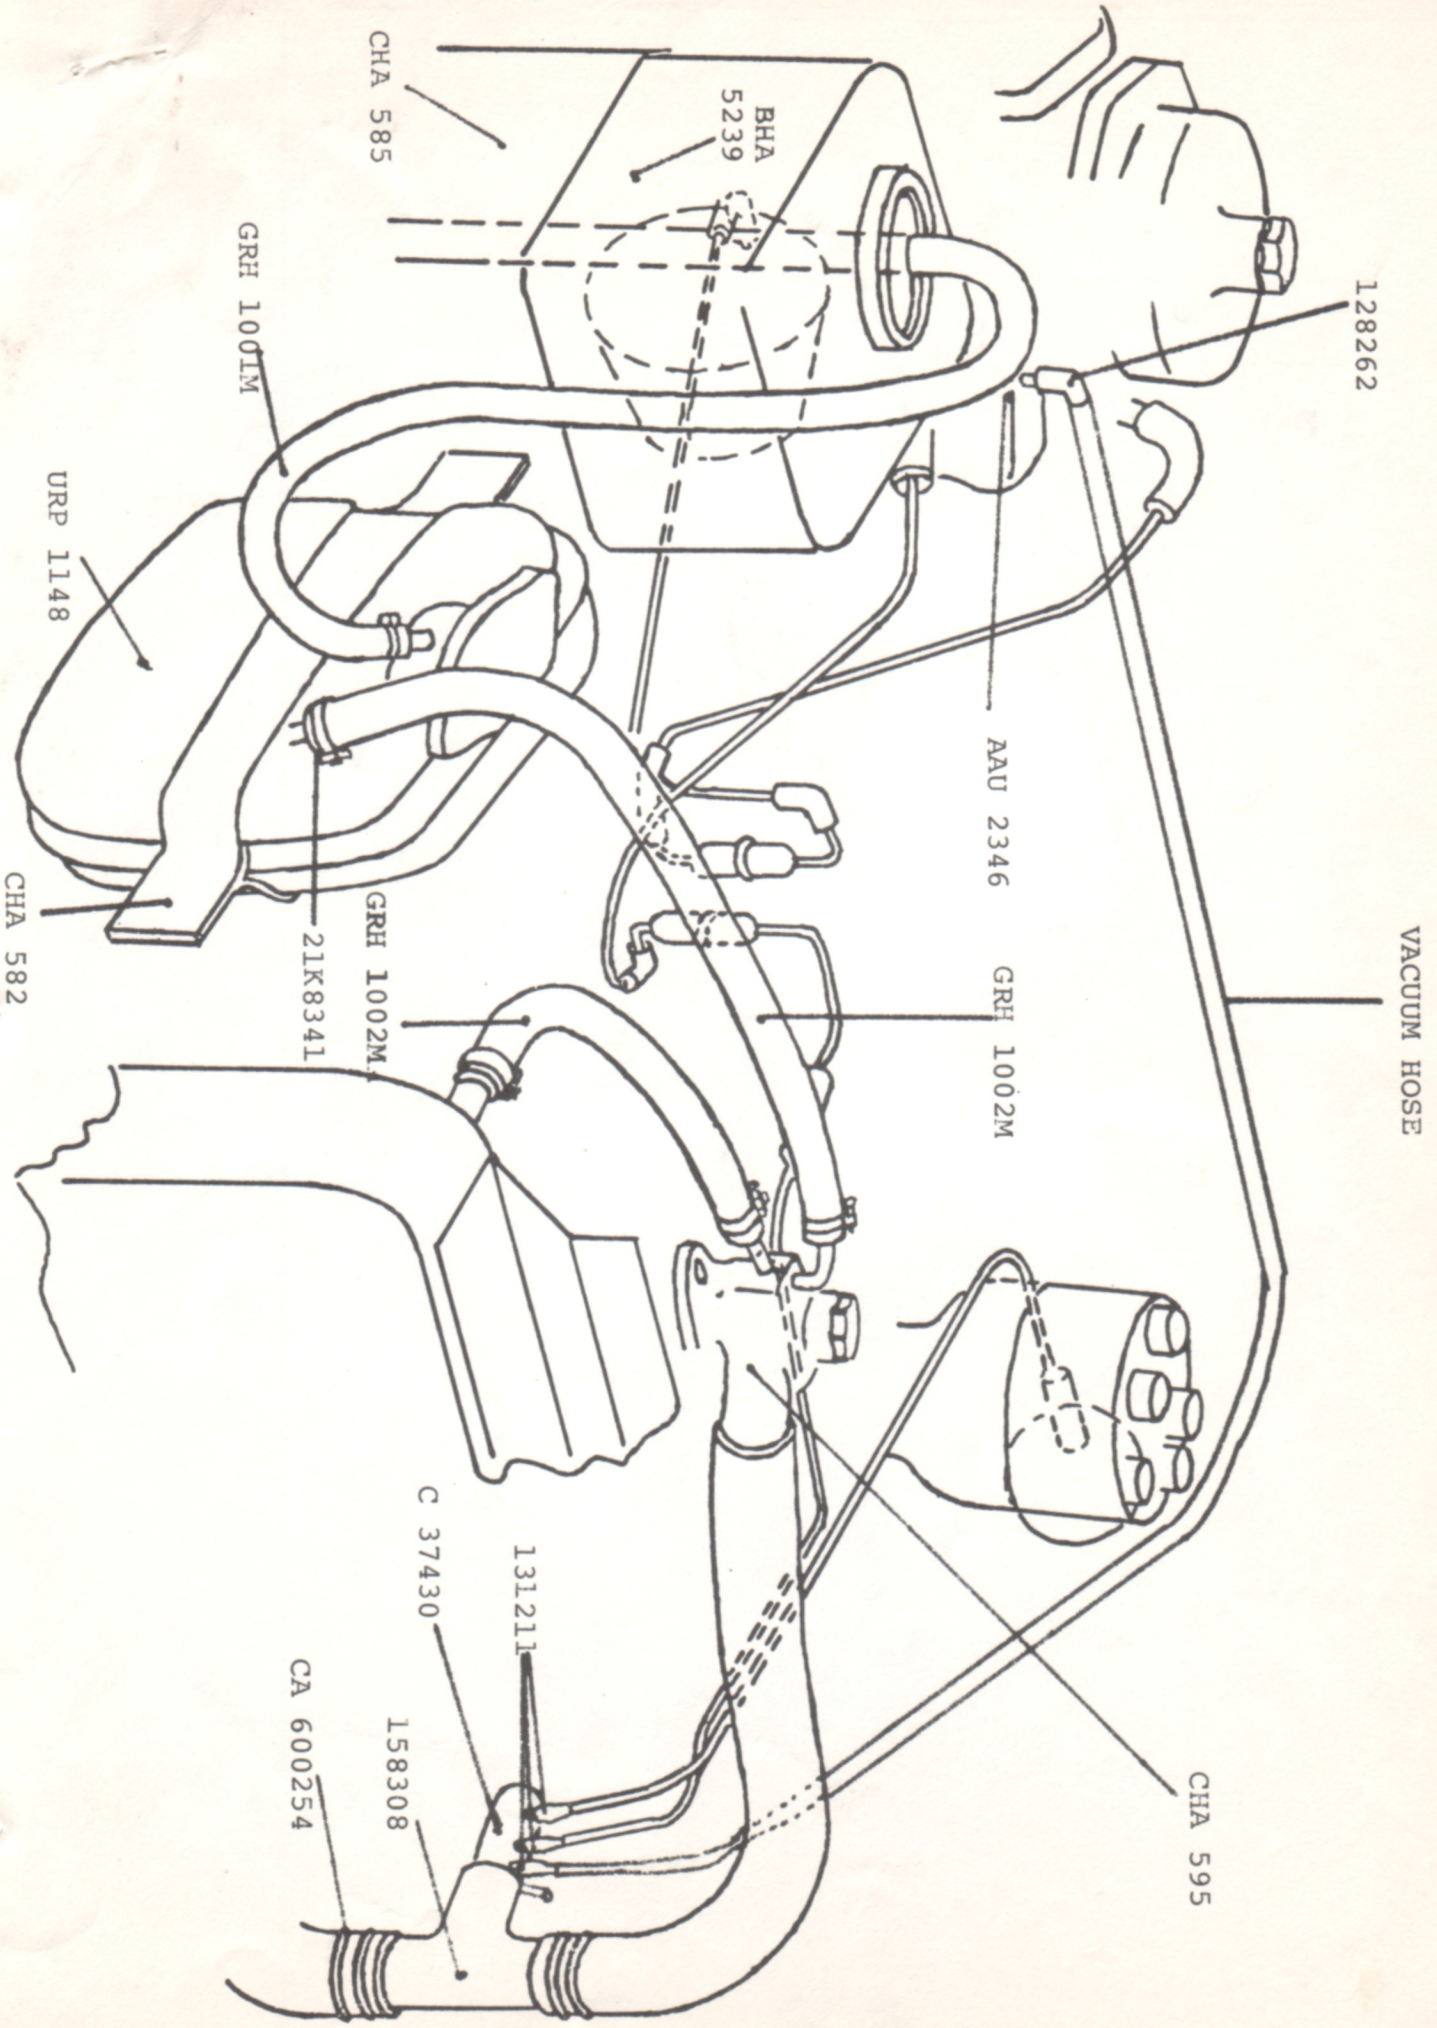
NOTE:- There are many reasons why an engine will overheat, consequently it is essential to establish that no other Where instance of severe overheating occurs on 1975 MG Midgets, the following modifications should be carried out.

NOTE:- There are many reasons why an engine will overheat, consequently it is essential to establish that no other problem exists, such as cylinder head gaskets, loose cylinder head bolts, incorrect ignition timing or maladjusted fan belt, etc., prior to carrying out the foregoing modifications.

1. Remove and discard the front number plate bracket and plinth assembly. Relocate and mount the front number plate to the center of the bumper, using self-tapping screws.
2. Reposition both horn assemblies by simply bending the mounting bracket upwards and through 90°.
3. Install thermo-vac switch, Part No. C-37430 with 'T' sleeve adaptor, Part No. 158308 in the top radiator hose as shown.

NOTE:- (Remove approximately 1 1/4" from the existing hose to accomodate the 'T' sleeve.)

4. Remove the decell valve from the carburettor and replace with externally vented valve, Part No. AAU-2346.
5. Remove and discard the existing expansion tank and replace with metal type, Part No. URP-1148, using the existing bolts and spacers and new brackets supplied, Part No. CHA-582.

NOTE:- The pressure cap supplied with the metal tank has a double seal, and therefore is not interchangeable with the original cap which should be discarded.

6. Install bracket, Part No. CHA-585 and no-loss bottle, Part No. BHA-5239, utilizing the right-hand upper shock absorber support plate bolts.
7. Remove and discard the thermostat housing and install modified housing, Part No. CHA-595.

8. Connect the vacuum and water hoses as shown in overall illustration.

NOTE:- Vacuum hose will have to be cut to length.

9. Pressure test system for any leaks.

10. Replace temperature gauge assembly, Part No. AAU-2641. Please note all displaced parts should be returned to your Distributor intact.
