Austin MG

WINDSHIELD DRY GLAZING
CONFIGURATION/ASSEMBLY PROCEDURE

MARINA

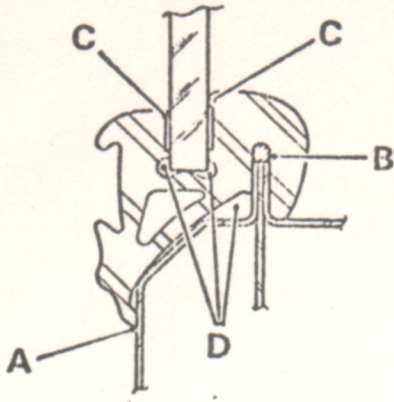
FIG. 1

The principle of 'dry glazing' (Fig. 1) is to direct any water leaking past the glazing rubber primary seal 'A' around the screen aperture to the drain tubes.

Water entering past the rubber to glass seal 'C' is directed around the water channel 'D' until it reaches the bottom corners where it passes through holes in the rubber and into the drain tubes.

SECTION THROUGH GLAZING RUBBER

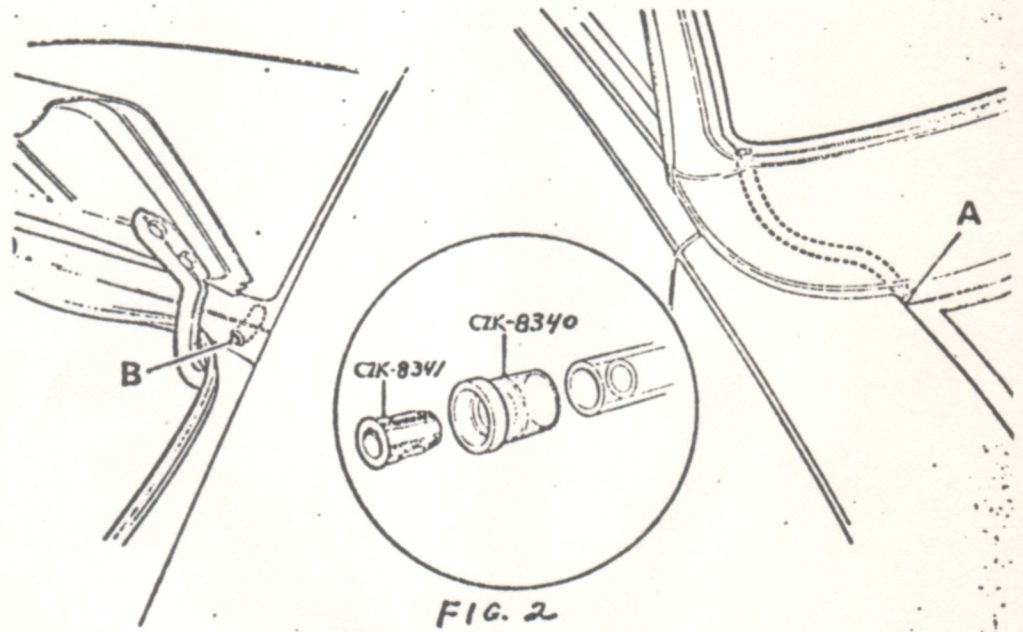
FIG. 2

If the outlet fitments at A or B located in the drain channels are leaking, these can be refitted without removal of the glass assembly. Access to the tube is provided in the dash top panel or from the trunk.

Using new parts, grommets CZK 8340 and inserts CZK 8341, assemble as shown. Push the plastic tube through the hole in the panel, push sleeve firmly onto tube, push assembly back into panel and press insert into sleeve. It is important for the head to be flush with the grommet and not distorted - for this operation it is essential to make up a simple tool (Fig. 3) as illustrated.
