Austin MG

august, 1976

WINDTONE HORN ADJUSTMENT

ALL MODELS

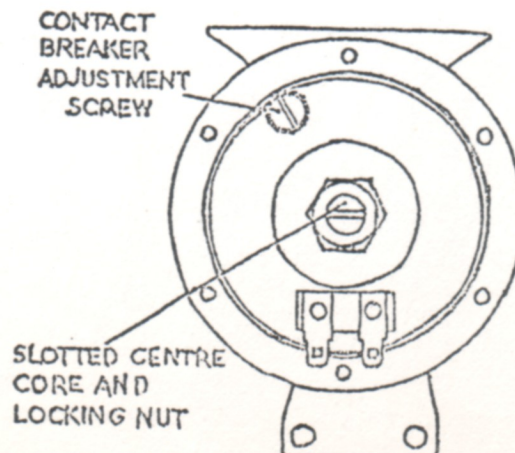
If a horn fails to sound or its performance becomes uncertain, the fault will not necessarily be in the horn. It is important to first see that the trouble is not due to such defects as a loose or broken connection in the wiring of the horn circuit or to a blown fuse. In this event, examine the wiring for the fault and rectify accordingly before renewing the fuse with the spare provided. Poor performance can also be caused by loosening of the fixing bolts. Check and tighten as necessary.

If two horns are fitted, disconnect one whilst adjusting the other, taking care to ensure that the supply cable removed does not come in contact with any part of the vehicle metalwork. Adjustment of the contact breaker does not alter the pitch of the note, but merely takes up wear of moving parts. A small serrated adjusting screw is provided on that side of the horn at which the cables terminate. Turn this screw anti-clockwise until the horn just fails to sound, then turn it back clockwise for about one quarter of a turn.

WARNING:- It is essential that the slotted center core and its locking nut are not disturbed when carrying out the above adjustment.
