0	Confidential TECHNICAL SERVICE BU BRITISH AUSTIN	DIVISION RS INC.	NO. 2 A 35 NO. May 18, 1969	and a state of the
SUBJECT:	Engine Steady Bar	MODELS:	Austin America Automatic	100 - 001

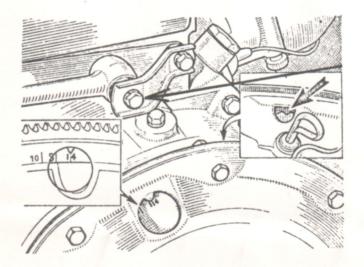
Isolated cases have been reported of the engine steady bar to cylinder block securing bolt working loose and in extreme cases eventually breaking.

Would you please advise all service personnel to check and tighten this bolt if necessary during routine maintenance services.
