# TECHNICAL SERVICE BULLETIN

**British Motor Holdings (U.S.A.) Inc.**

February 29, 1968

Re: Intermittent Operation of Windshield Wipers

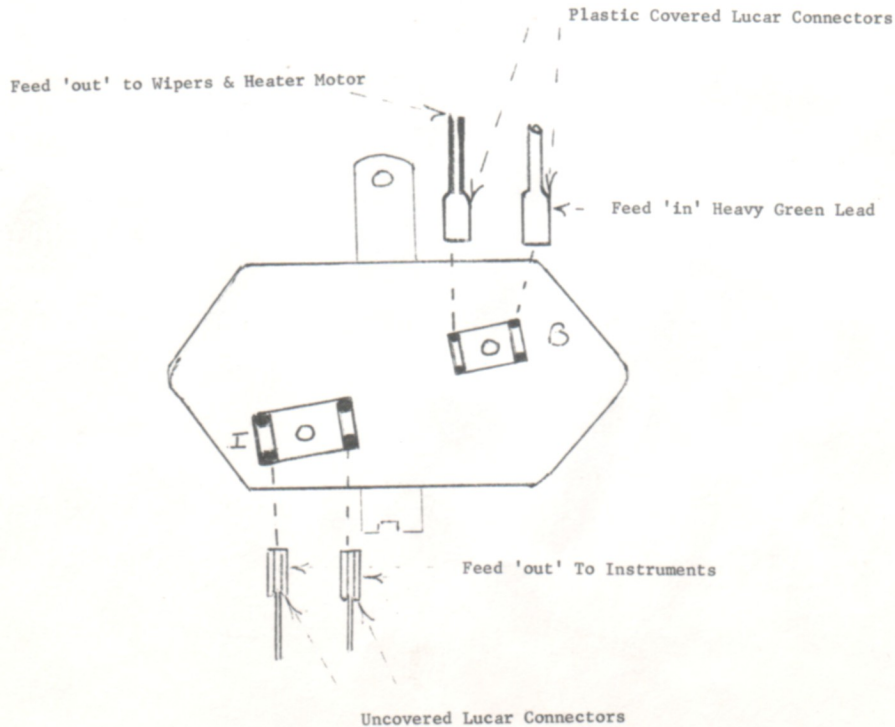
The above problem has been traced to incorrect wiring of the voltage stabilizer mounted behind the instrument panel.

Ensure that the heavy green feed lead and the two feed out leads to the wipers and heater motor are connected to the "B" terminal on the stabilizer. You will note both these leads have lucar plastic covers over the connectors.
