TECHNICAL SERVICE BULLETIN

British Motor Holdings (U.S.A.) Inc.

Re: Waist/Door Pillar Cracks

Morris Minor 1000
2-Door Saloon

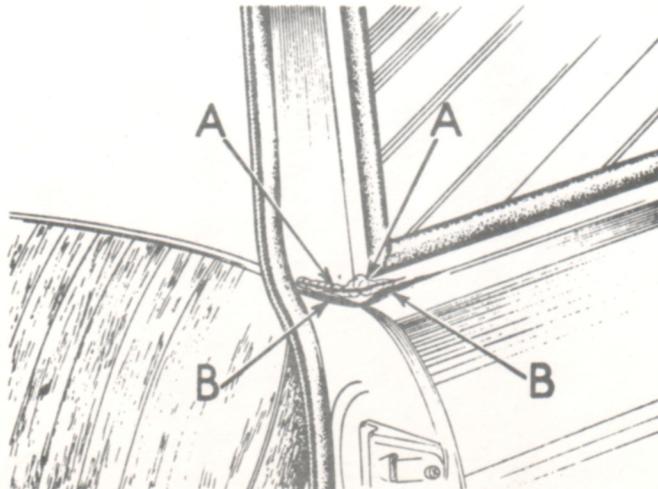
Any cracks appearing in the positions shown may be rectified as follows:

1. Remove door sealing rubber, quarter light and trim liner.
2. (a) Existing weld around crack 'A' and lead loading should be cleaned off completely by discing.
(b) Crack along panel edge at 'B' should be cleaned thoroughly but no discing is necessary.
3. Gas weld (not braze) deeply all round cracks, building up weld to prevent burning away existing metal.
4. Disc and clean joint all round new weld to prepare for lead filling.
5. Lead fill area and file carefully to original contour.
6. Repaint as necessary.
7. Refit trim liner, quarter light and door sealing rubber.
