TECHNICAL SERVICE BULLETIN

March 1, 1968

Re: Body Drainage Apertures

Mini, 1100

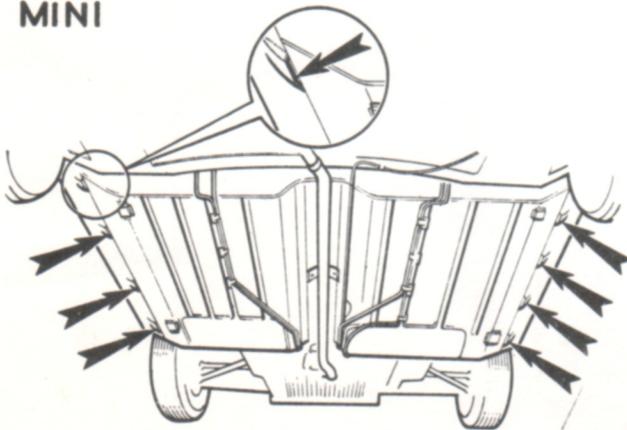
MINI

To reduce the possibility of sill corrosion, periodic examination of the drain holes illustrated should be made to ensure they are clear and have not been deformed in any way.

Incorrect location of the jack (i.e., failure to use the jacking points provided) may damage the apertures. Also careless application of a sealer to the underbody floor may result in restricted drainage, if not complete blockage of the apertures. All concerned should be reminded that adequate masking is necessary before commencing under-sealing operations.
