Confidential
TECHNICAL SERVICE BULLETIN

NO. 2 C 8

SUBJECT: WINDOW REGULATORS	MODELS: AUSTIN AMERICA
-----------------------------------	-------------------------------

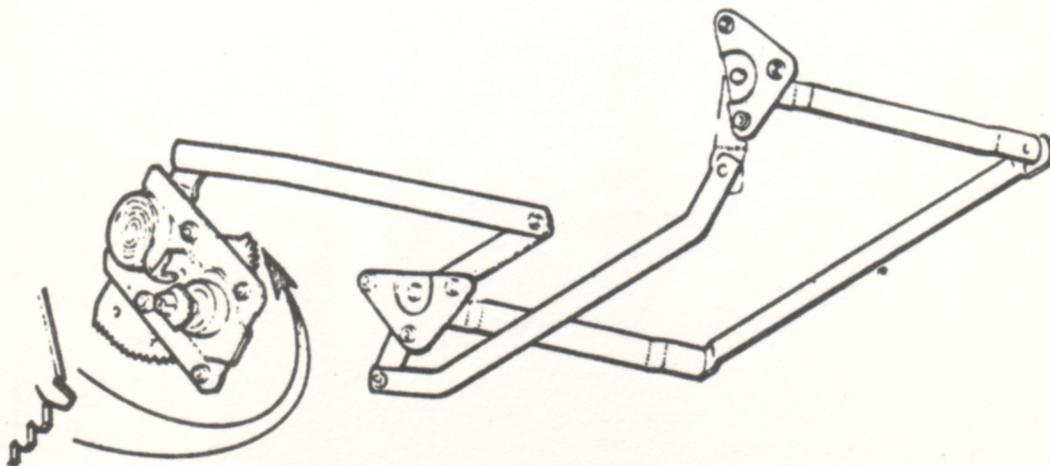
Overwinding of regulators Part No. CZA 2126 RH and CZA 2127 LH, i.e., disengagement of quadrant from clutch, may be prevented as follows:

1. Remove regulator from door, as per Workshop Manual.
2. Re-engage quadrant teeth in clutch, clamp quadrant in vice and turn last tooth on the side of quadrant nearest the linkage as shown.
3. Replace regulator.
