LUCAS WORKSHOP INSTRUCTIONS

FLASHING-LAMP DIRECTION-INDICATORS

TWO PANEL WARNING LAMPS

Section I-5, Para. 1 and Fig. 2

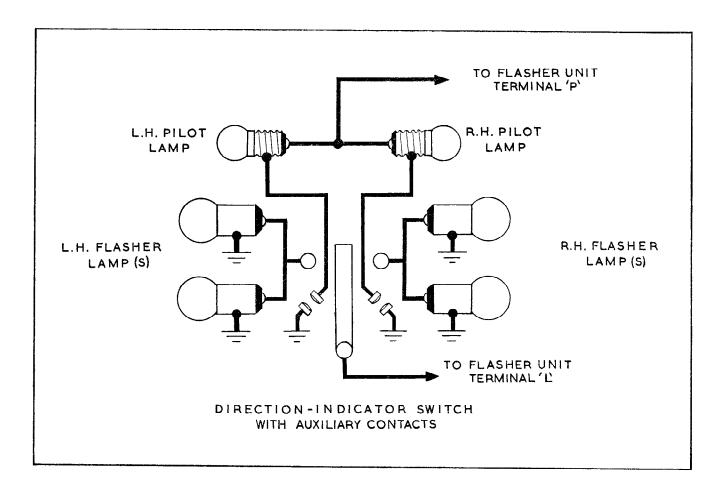
It has become standard practice to arrange that a pilot warning lamp shall cease to flash and remain unlit as an indication of bulb failure. It is desirable that this same indication is given whether one or two warning lamps are fitted. A disadvantage of an earlier two-lamp system described in SECTION I-5 was that this method of indicating bulb failure could not be followed.

However, certain direction-indicator switches (such as model 13SA) are now being produced which enable the normal bulb failure signal to be given when separate left-hand and right-hand pilot warning lamps are fitted. When a switch incorporating this feature is operated, one of two auxiliary contacts completes an earth return circuit for the appropriate pilot warning lamp, as shown in the diagram below.
