Confidential
TECHNICAL SERVICE BULLETIN

NO. 3 A 7

Cooling System Expansion

Austin America

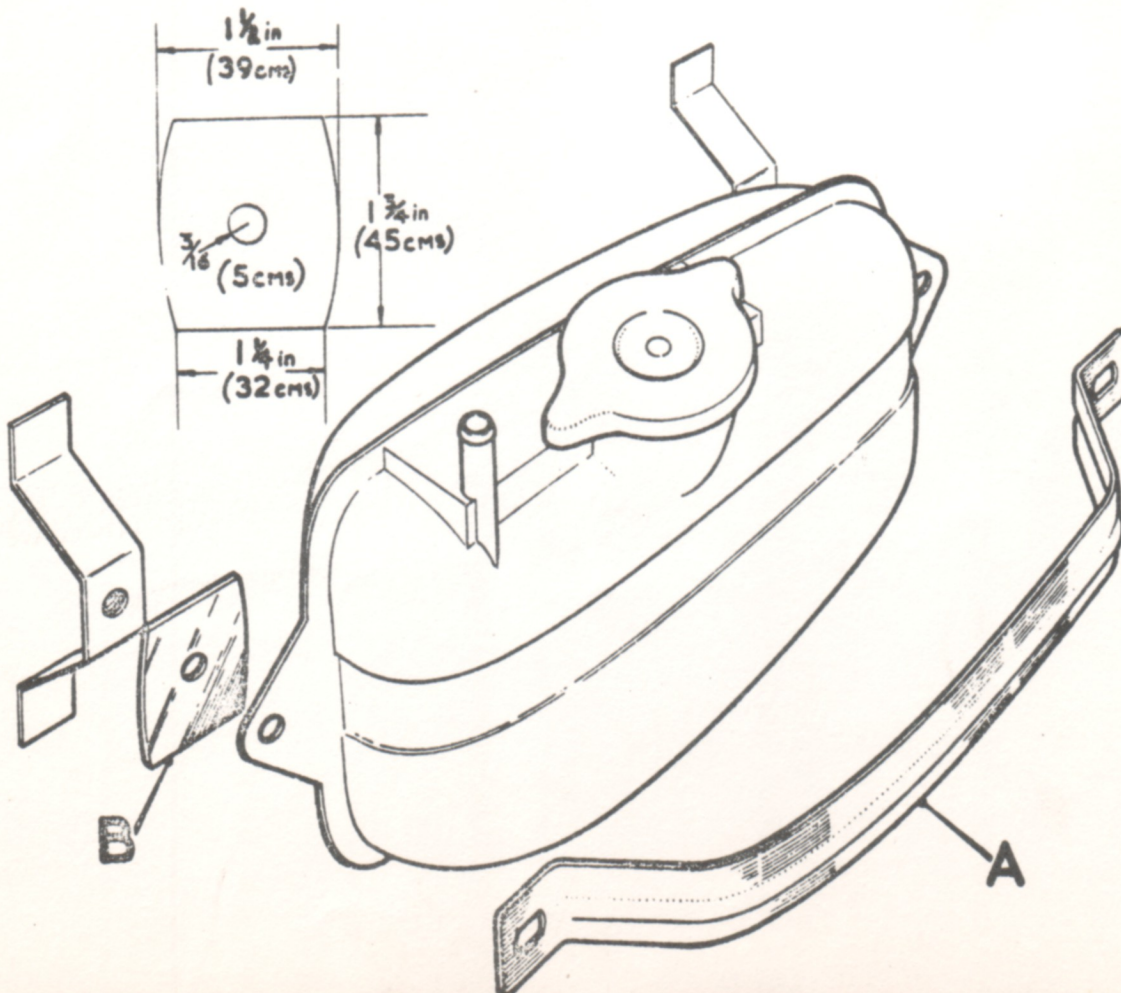
In the event of expansion tank fitting lug breakage, the tank can be refitted using a support strap as illustrated below.

These can be made locally from 16 gauge mild steel to the dimensions shown or ordered under part number ACA 1791 strap 1 of, and 31G 1181 mounting plate 2 of.

The mounting plates must be fitted between the tank and the body brackets with curved edges directed towards the tank.
