BRITISH LEYLAND MOTORS INC.
600 Willow Tree Road • Leonia • New Jersey 07605

Front Seats

Austin America

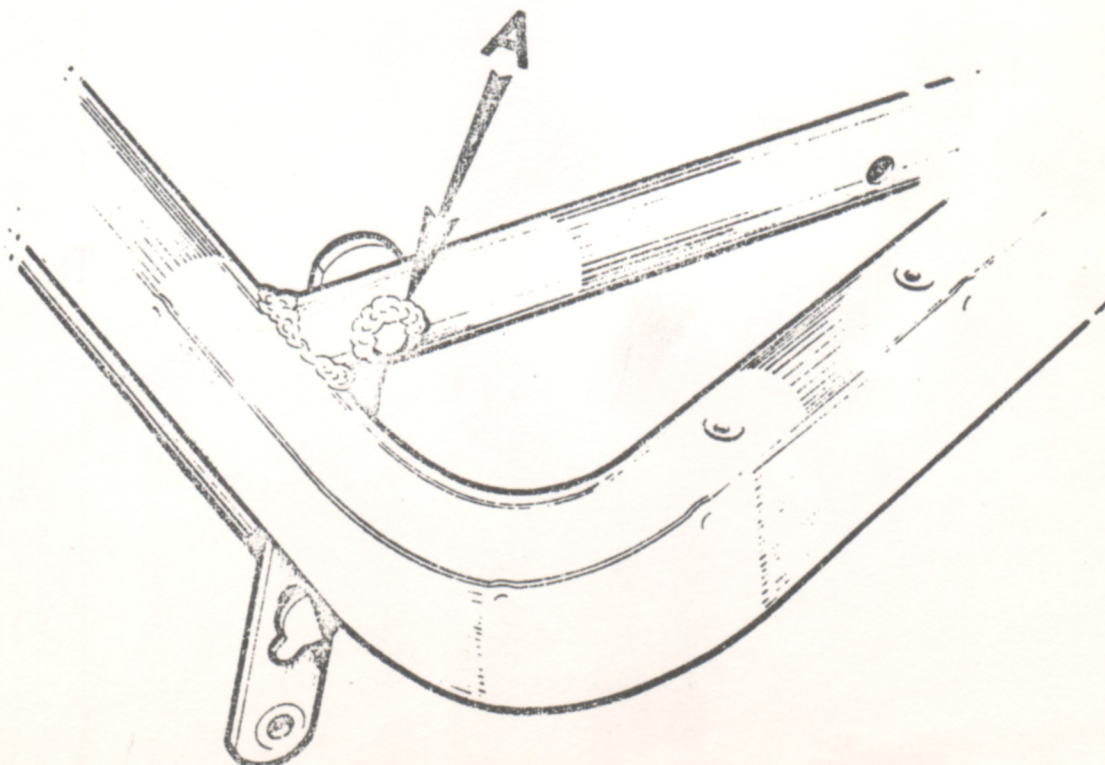
Rattles from front seat frames may be caused by loose leg pivot pins.

- (1) Examine pins 'A' in frame tube.
- (2) If loose, remove seat cushion cover and foam pad.
- (3) Arc weld round end of pivot pin as shown attaching pin to tube.
- (4) Clean off and touch in with black paint.
- (5) Replace foam pad and cushion cover.
