TECHNICAL SERVICE BULLETIN

NO. 2 B 23

Re: Bulb Replacement Brake Pressure Check Light Switch

All 1968 Models

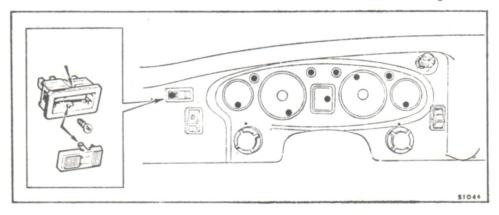
To replace or tighten the bulb in the Brake Pressure Check Switch, remove the switch assembly from the facia panel, Austin America and early sports cars by depressing the four lugs on the outside of the switch casing. Gently press the switch rocker pivot lugs inwards and withdraw the rocker with lens from the casing.

NOTE On the later 1968 Sports Cars the above switch is held into the facia panel by a wire clip. Push the clip in direction of the arrow to remove the switch.

Push spring clip in this direction.
